## Force Investigation Team Report

### Officer-Involved Fatal auto-pedestrian Accident

Incident: Officer-Involved Fatal Auto-pedestrian accident

Location of Incident: Intersection of 27<sup>th</sup> and Washington

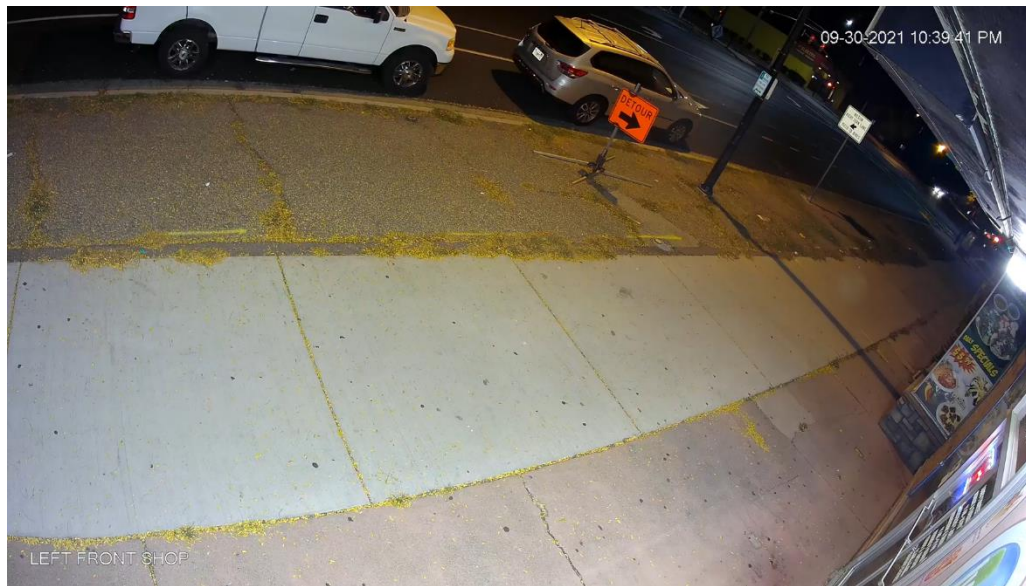
Investigators with FIT conducted a canvas of the neighborhood looking for surveillance footage of the incident. They located a security camera at Ivan's Ice Cream located at . The camera was pointed in a southern

direction and captured the accident from a distance. [Note: The below photo was a still photo taken from the surveillance video as it appeared that night. The series of still photos shown after that were taken from an enhanced version of the surveillance video. In the enhanced version the image was lightened to further assist the reader in seeing the objects. end of note]

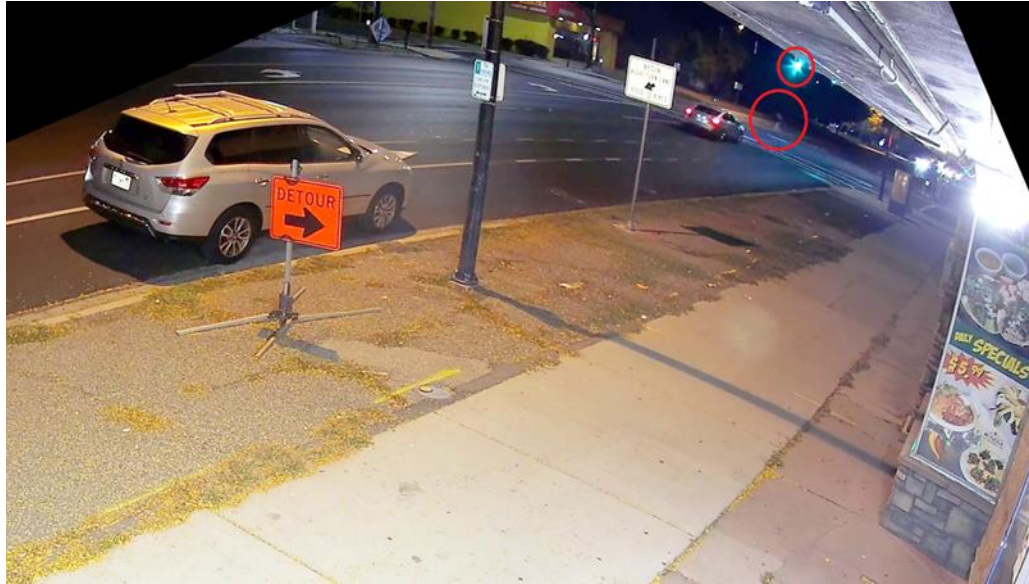
As Casselman was walking across the street against a do not walk signal the light for North and South turned green. At this point, Casselman was still crossing East and had barely reached the #1 travel lane for Southbound traffic.

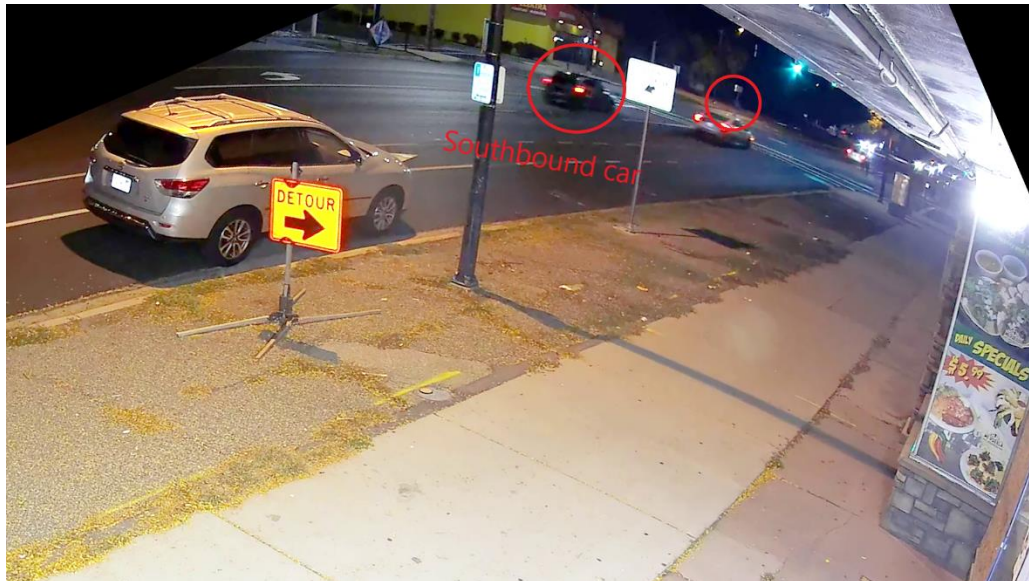
As Casselman continued crossing just as he reached the center turn lane, just as he did so a vehicle went through the intersection in the #1 Southbound travel lane and did not appear to slow or brake, indicating that the driver probably didn't see Casselman crossing.

As Officer Tavake approached the intersection he failed to see Casselman in the crosswalk, striking him with his car. Evidence suggesting that Casselman was difficult to see while he was in the intersection, can be observed on the surveillance footage. As Casselman was in the middle of the road, there was a vehicle that came through the intersection traveling southbound. This vehicle did not slow down or hit the brakes.

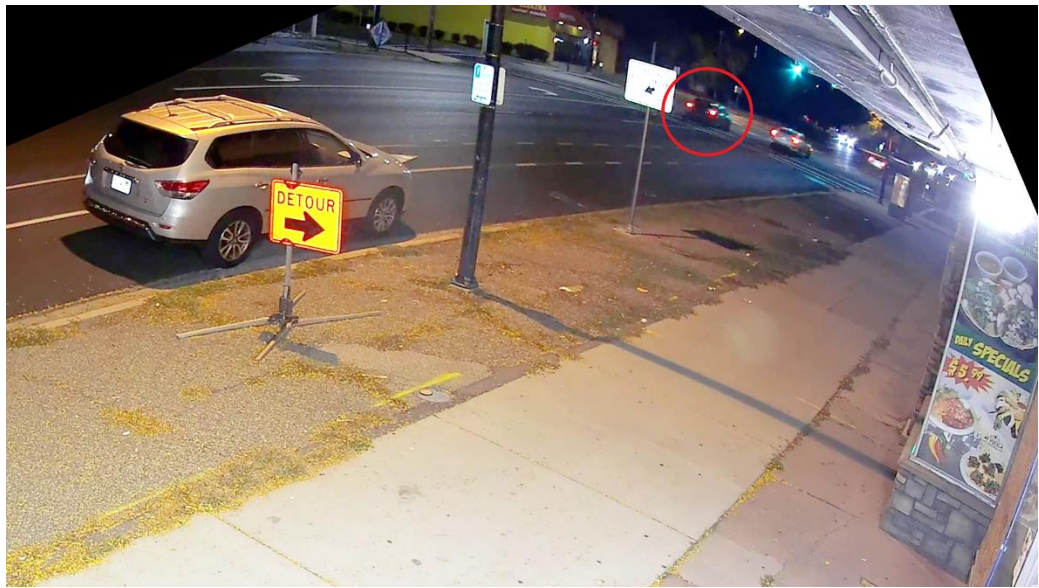
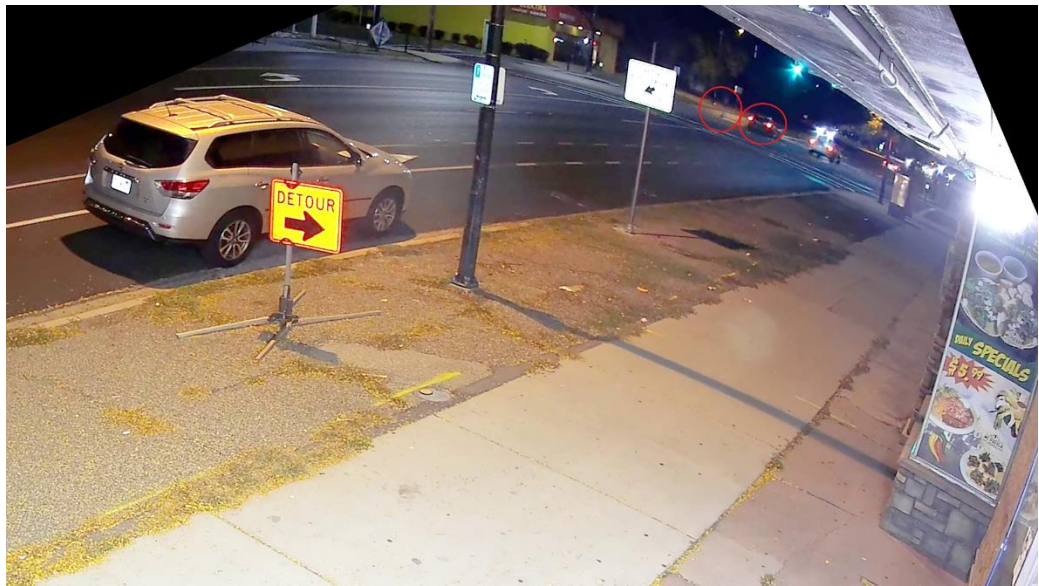
Casselman continued to move East and into the #1 travel lane at this moment Officer Tavake was traveling Northbound in the same lane, the Officer did not stop or slow, indicating that he probably did not see Casselman.

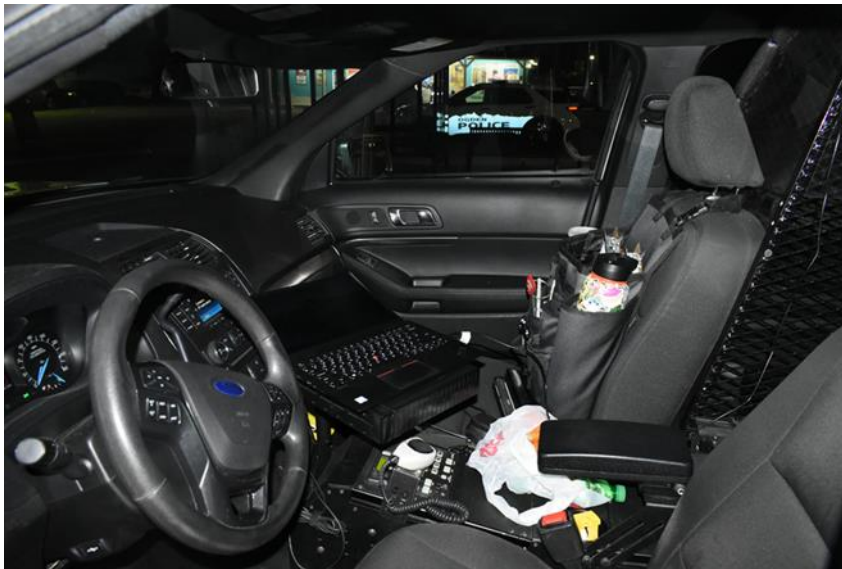
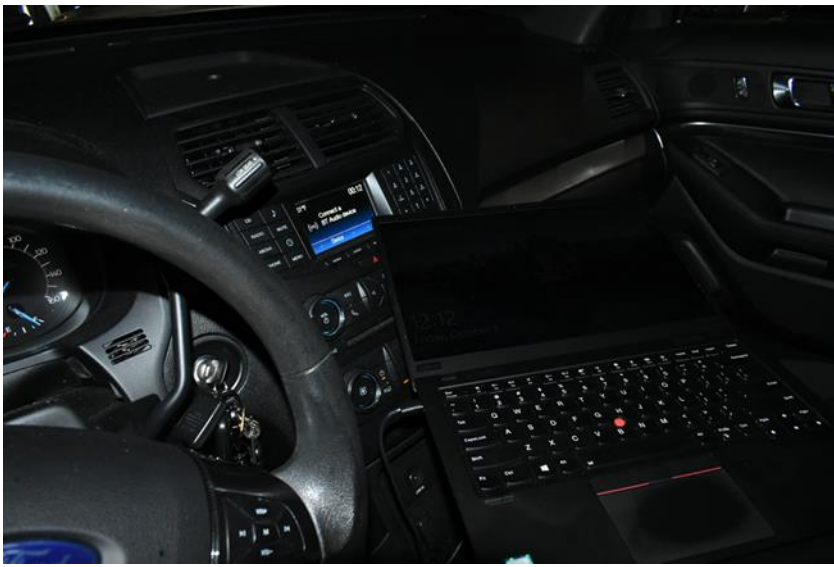
Officer Tavake had a laptop computer in his vehicle.

He was not dispatched to a particular car but was doing “premise checks” or security checks on Weber State-owned buildings. At the time of the accident, Officer Tavake had commented to a responding Ogden Police Officer that “I down at the CAD and looked up and the guy was right there.”

When the laptop was unlocked the CAD screen became visible, which matches Officer Tavake’s excited utterance that he had looked at his CAD before the
